Final Report for BIA Watershed Restoration Grant: Riparian Restoration in the Dickey Watershed of the Quillayute River System

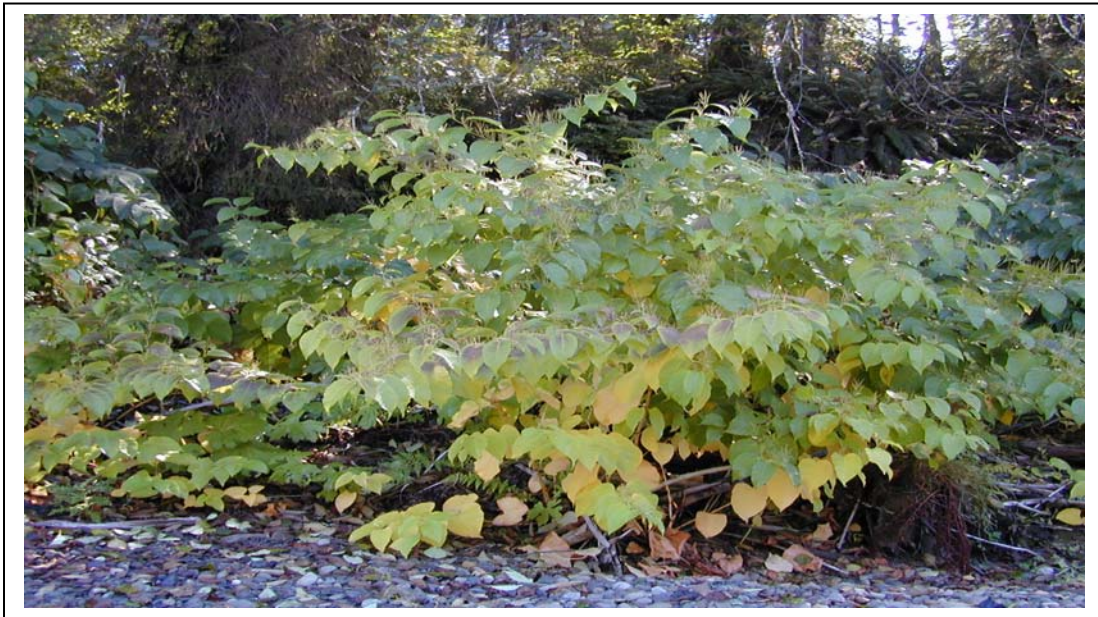
A knotweed cluster on the Dickey River

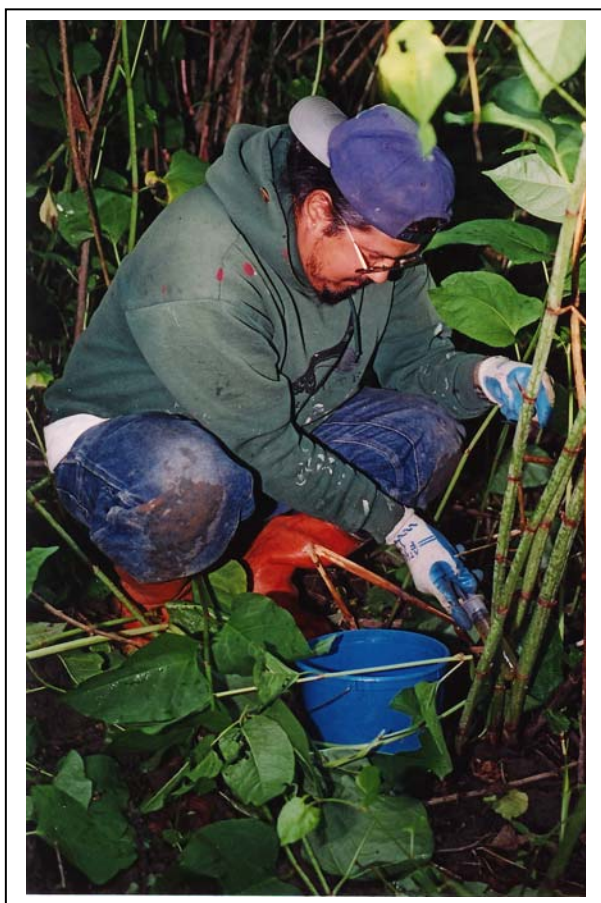
Quileute technician using injection method on knotweed in Dickey River sub-basin.

Injection methods were as follows: Each technician was equipped with an awl, a 16 gauge needle, and 60cc syringe and a lidded bucket of 100% solution of Aquamaster. Technicians pierced the stalk of each stem completely at the first or second node of the plant. This allowed easy entry for the needle injection and also allowed water in the stem to be displaced by chemical as it was injected. The chemical is heavier than water and sinks to the bottom of the node, displacing any water within. At a downward angle, approximately 5cc of herbicide was applied to each stem within a patch location.

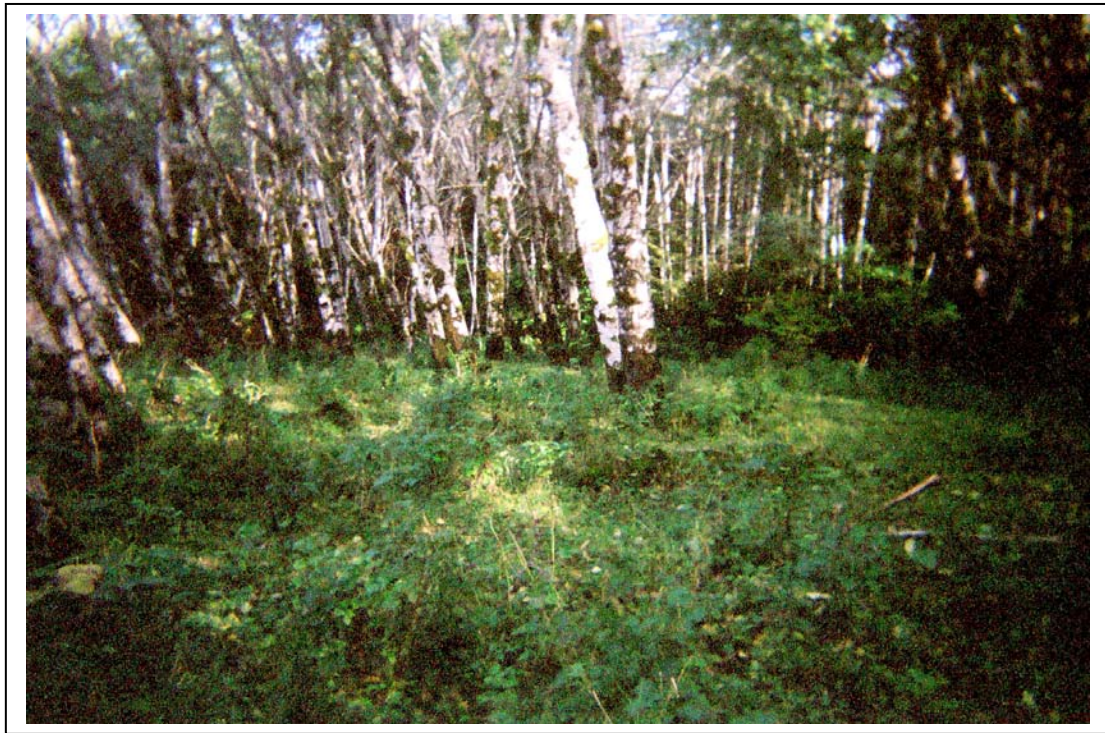
This picture shows normal forest floor with native salmonberry.

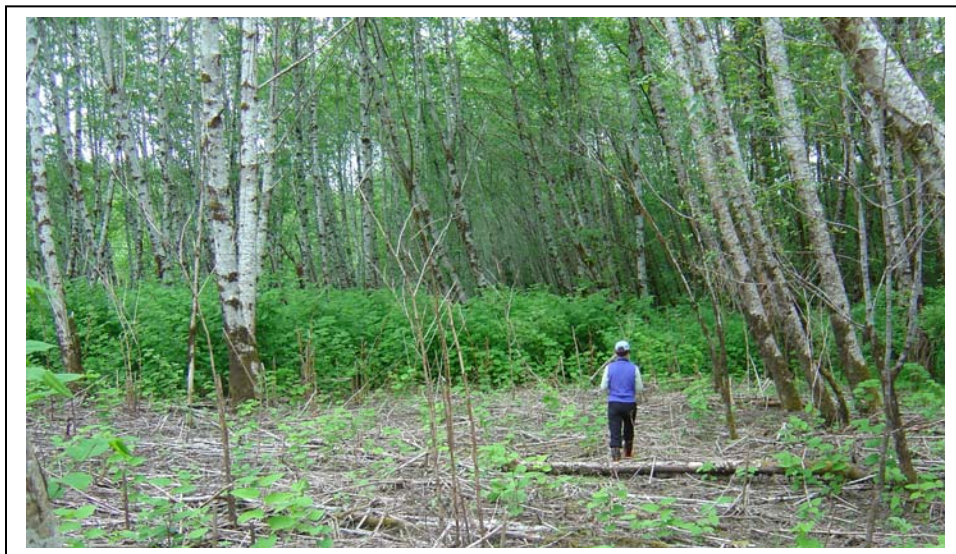
**Scattered knotweed remnants growing in riparian area along
Dickey River as seen in Spring of 2004 (Year Two)**

In the summer of 2004 Quileute technicians treated over 344,000 plants in 92 documented locations, covering approximately 3 miles of shoreline and associated riparian area. Results from the 2003 efforts almost completely removed the plants from the treated areas. Only scattered solitary plants were observed growing back in treated areas the following spring of 2004. (See photos below.) These solitary plants were treated the following season and by the end of the treatment season of 2004, knotweed plants were non-existent in these treated areas. Native vegetation including grasses, herbs, and shrubs were observed growing the following spring in all the treated areas. Both the foliar and injection treatment methods proved to be very successful. .

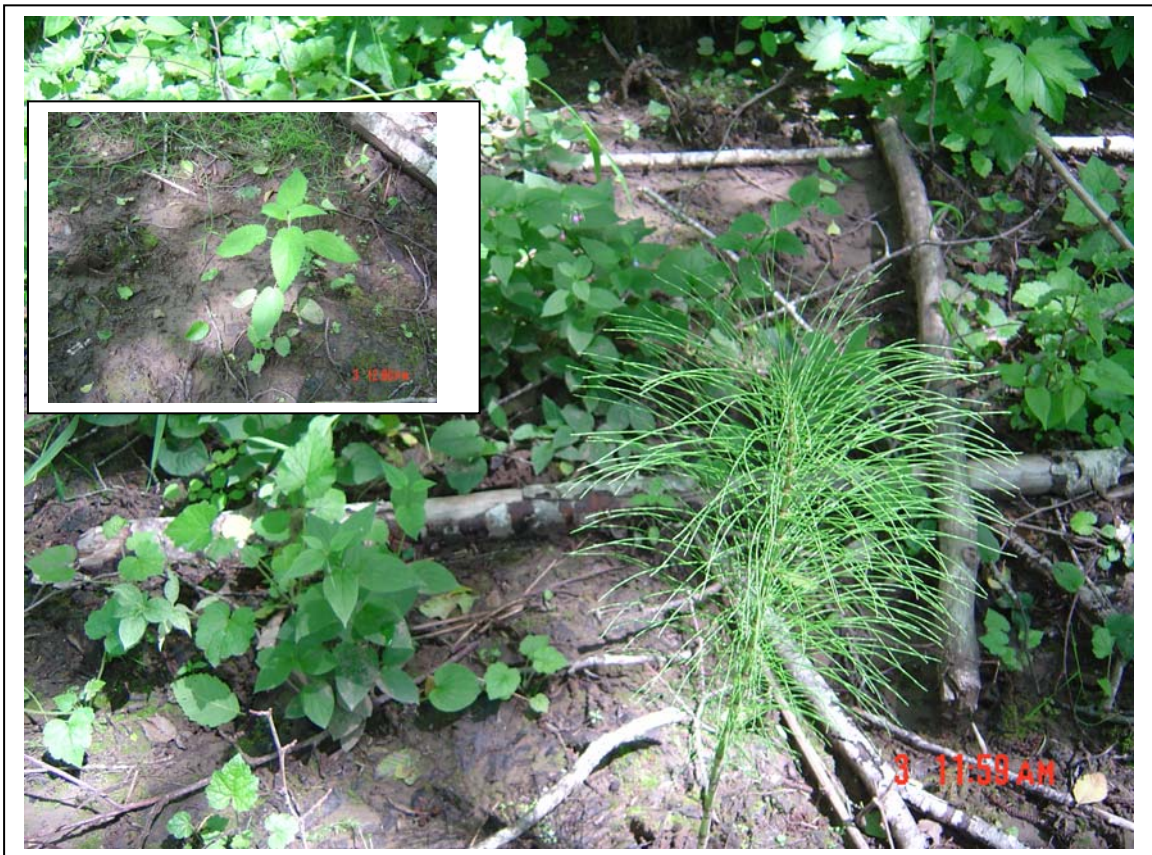
Native vegetation re-growing in treated area, spring 04. Horsetail, nettle.

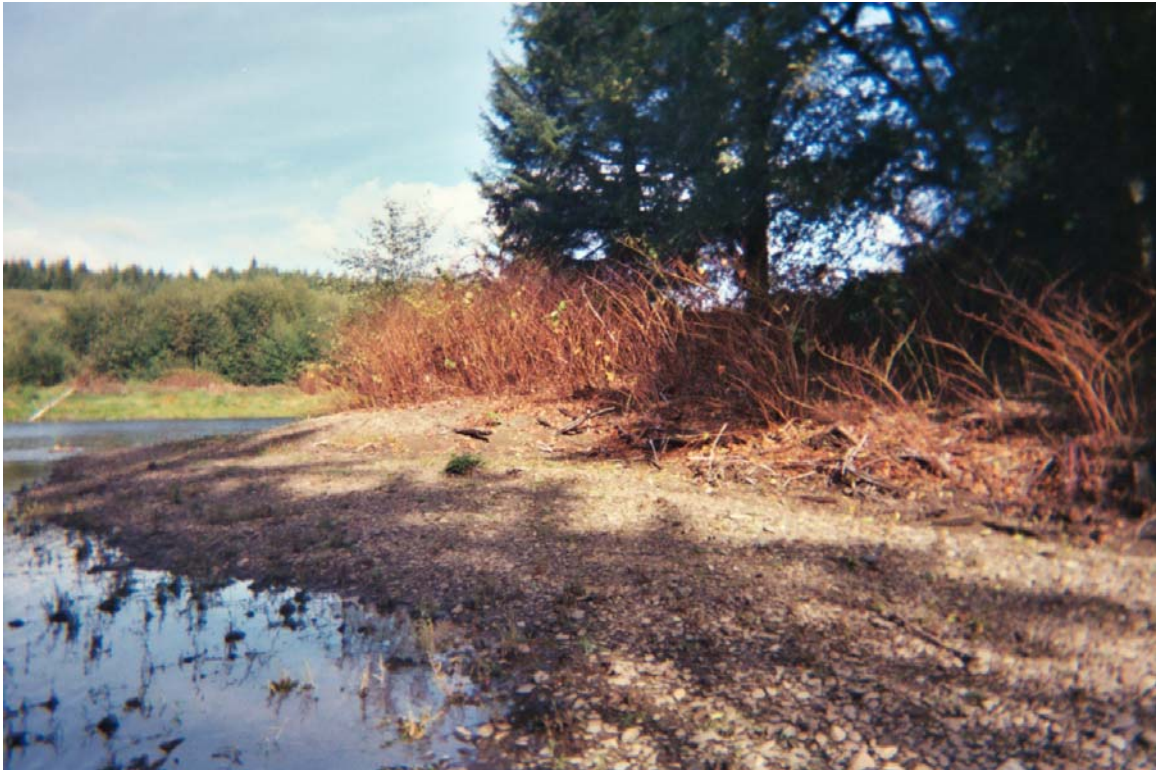
Treated knotweed via injection method along the Dickey River.

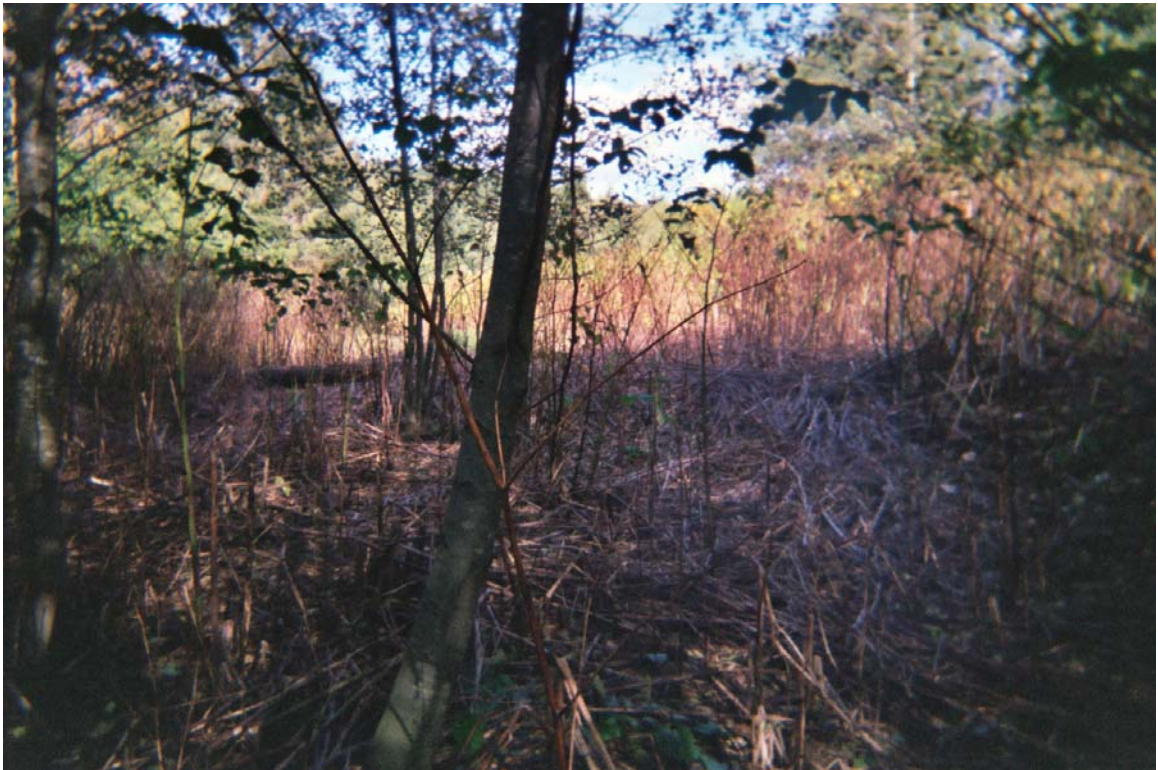
Knotweed treated via foliar application method in riparian along Dickey River off-channel pond complex.

biologists trained Quileute in use of foliar (spray) application. A foliar application was also used in areas where the possibility of overspray would not enter the water. Further, JK Injection Tools had developed and manufactured a gun for increasing the rate of injection by as much as four times. Ten guns with needles were purchased for this season. Needle injection by use of the new guns with 3cc of herbicide was used in all areas where foliar application was deemed (by our licensed applicator) to be a possible hazard to water. In all other areas a foliar application using backpack sprayers was used. A mixture of Aquamaster and water at 2.5-3% solution was used in the foliar application. A blue dye was added to the mixture to allow for physical observation of the treated areas by technicians. Foliar applications were not implemented during wet/windy days.

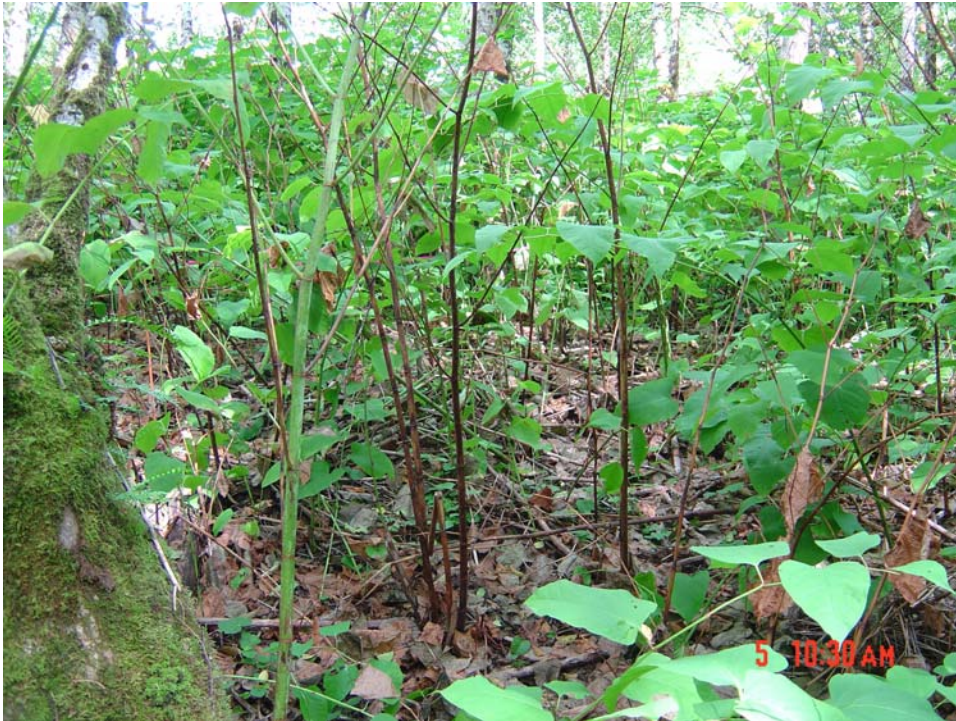
There appeared to be no significant difference between 2cc and 3cc application levels. Both produced kill rates of 95%. (When this happens in the field, we re-treat to kill the remaining plants.) The 1cc application appeared to kill only 54% of the injected stems. The rate that stems exhibited physical signs of treatment did vary between the 2cc and 3cc applications. Within one week of treatment stems in the 3cc plot were turning bright yellow and falling off, while stems in the 2cc plot were just turning a light yellow color with few leaves falling. Stems in the 1cc plot showed no visible signs of application after one week.

1cc test plot four weeks after application.

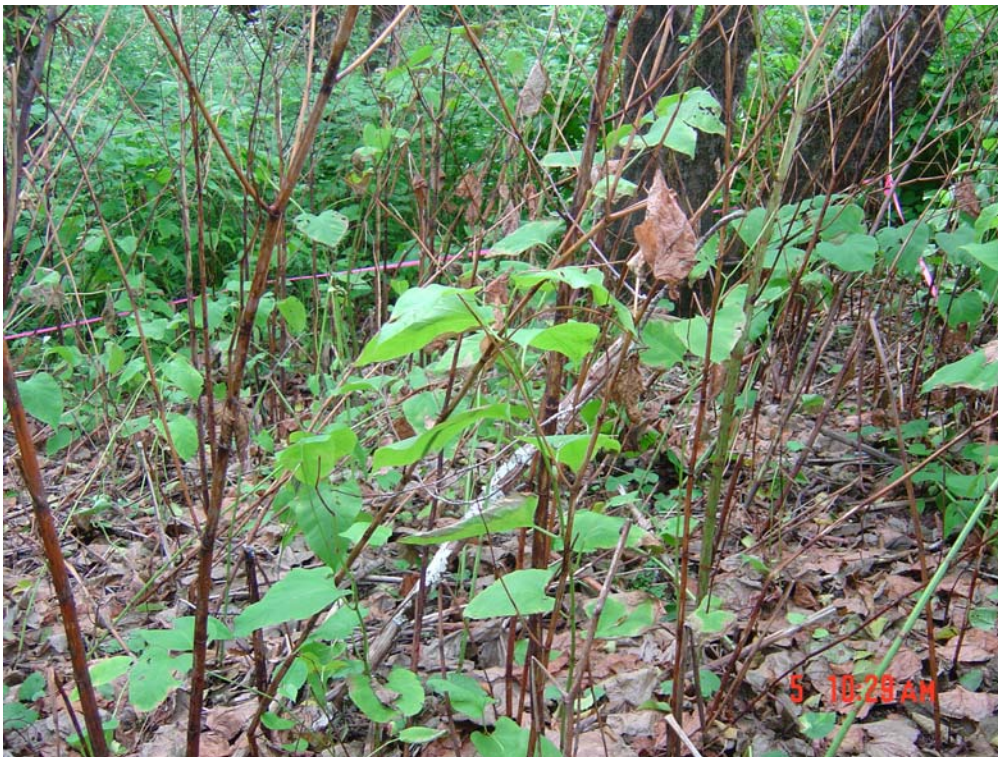
2cc test plot four weeks after application.

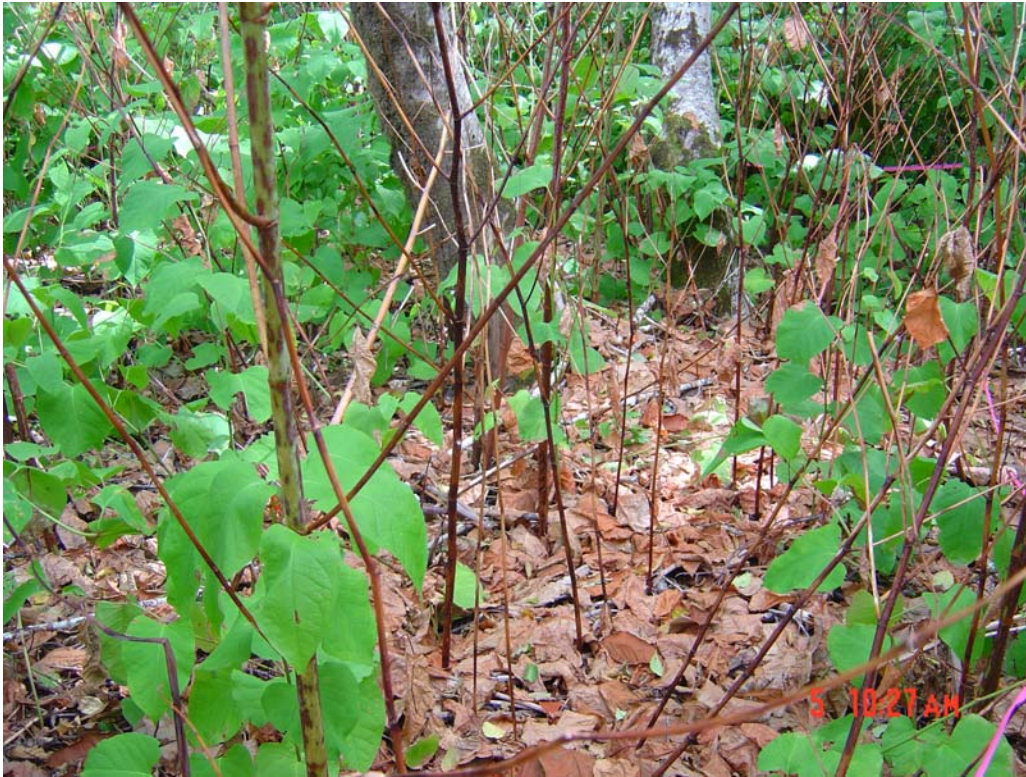
3cc test plot four weeks after application.
